Operation at the Antamina Copper-Zinc Mine in Central Peru

T. Eldridge and K. Moffitt
Golder Associates Ltd., Vancouver, BC.
S. Botts, and C. Dechert
Compania Minera Antamina, Peru

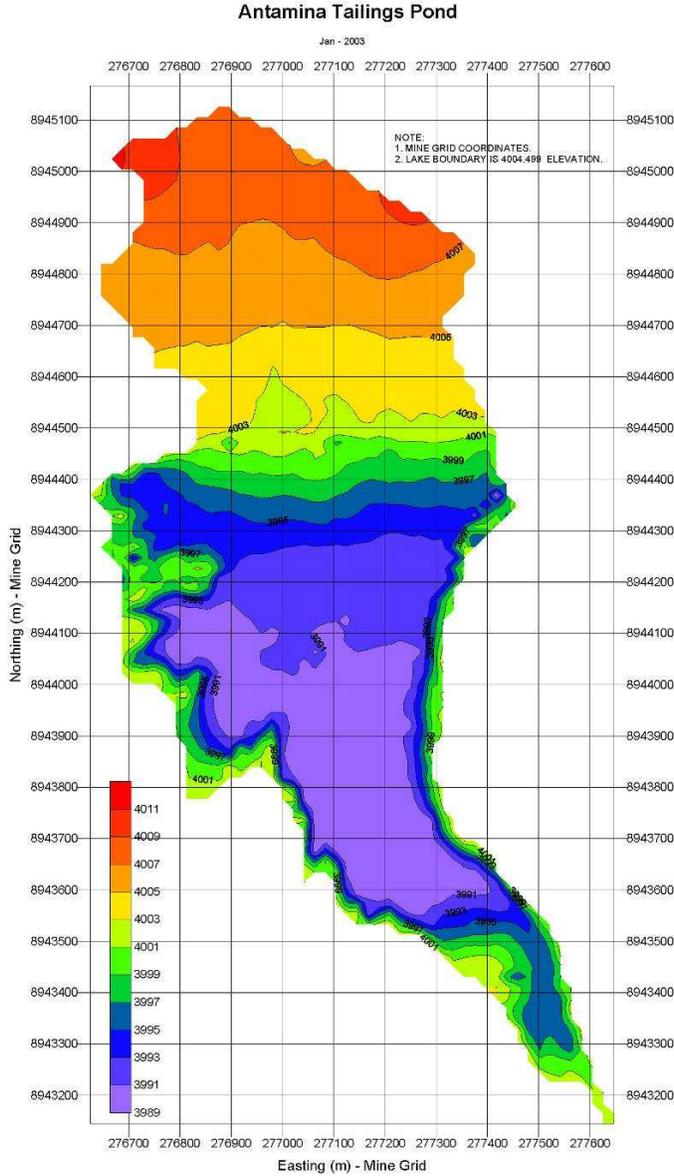
Figure 4
Bathymetry Survey: January, 2003

The tailings beach currently extends approximately 400 m from the tailings dam face at an average slope of approximately 1%. This is in general agreement with the tailings deposition plan. Below water, the average slope is approximately 5% over a height of approximately 10 to 15 m, at which point the slope flattens.

The design density of the tailings was estimated at 1.8 tonnes/m³. Based on the bathymetry results and the volume of tailings placed, the average

achieved density of the tailings is approximately 1.7 tonnes/m³, and has remained relatively constant with each successive bathymetry survey.

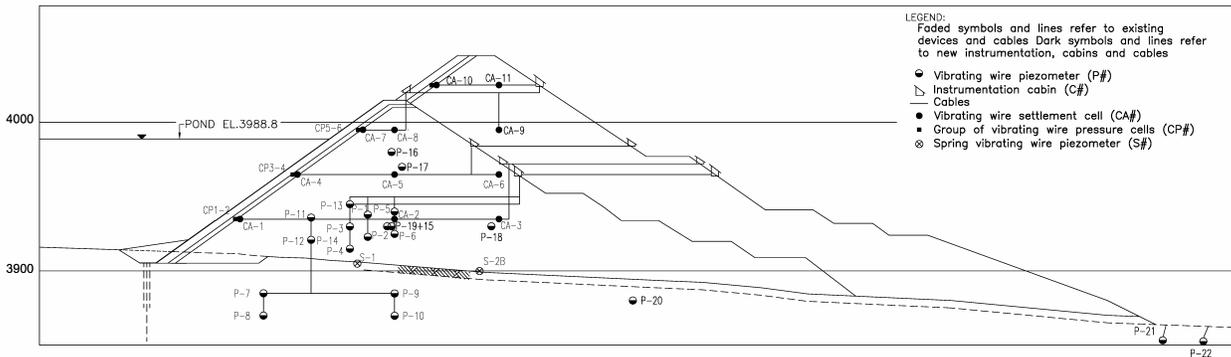
Figure 5
Main Instrumentation Section

Two of the vibrating wire settlement cells have failed since installation (CA7 and CA8). All other settlement cells have experienced erratic readings that do not appear obviously attributable to changes in the dam crest or reservoir elevations. Instrument malfunction may be the result of air in the water lines. Since construction of the dam is ongoing, the reservoirs for each instrument have been re-located several times since installation. The relatively long lengths of water line required between the instruments and their reservoirs and the continual splicing during each re-location introduce the potential for air entrainment in the lines. Instruments are currently being flushed with de-aired water. In the interim, judgment is required in interpreting whether sudden changes in settlement are indicative of 'real' movement, the result of movements or disturbance of the reservoir or other equipment malfunction.

Comparison of predicted and measured settlements in Table 1 indicates a relatively good correlation up to the end of starter dam construction and completion of reservoir impoundment. Since approximately June 2002, data from settlement cells that are still operational indicate somewhat higher settlements than predicted from the model. Several possible reasons for the difference between observed and measured settlements include:

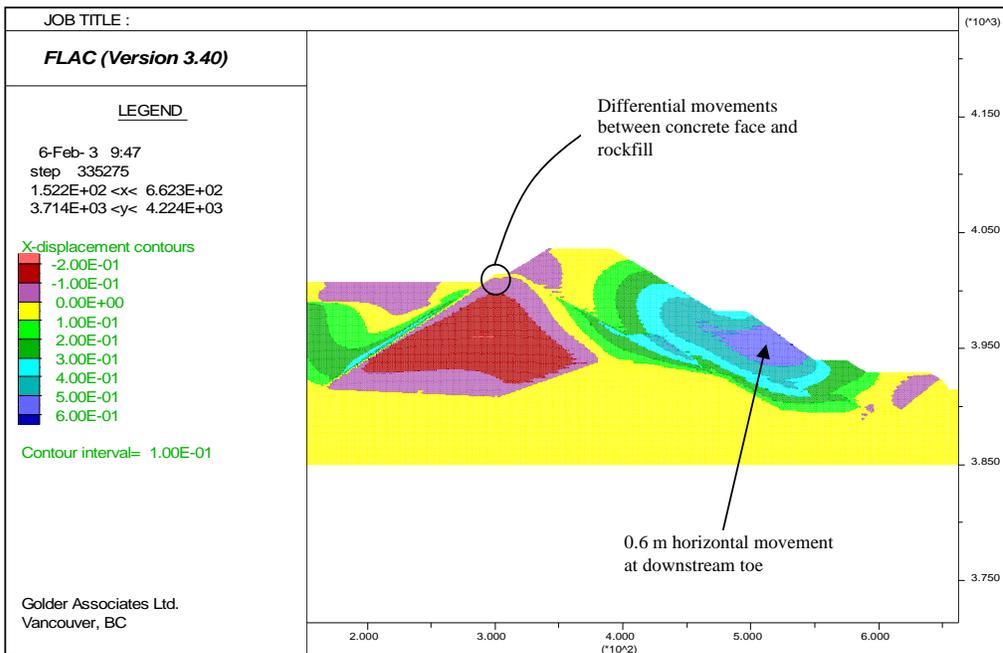
Figure 7
Contours of Horizontal Displacement

The primary objective of the numerical model is to enhance the conceptual understanding of *patterns* of dam deformations. As the analysis allows virtually any parameter to be tracked and plotted at any stage of the analysis, insight has been gained into the effects of additional raises and tailings deposition on the overall patterns of anticipated dam movements. The analysis also provides a tool to investigate the causes for observed deformations that were otherwise unanticipated. As an example, Figure 7 shows the predicted patterns of horizontal displacement at the current stage of construction, indicating the potential for bulging at the downstream toe of the dam. With more refined contours of the upstream crest of the starter dam, differential movements indicate conditions that may exist to result in crack development within the fill near the interface with the concrete face. Cracks were observed to develop at this location during Stage 1 construction.

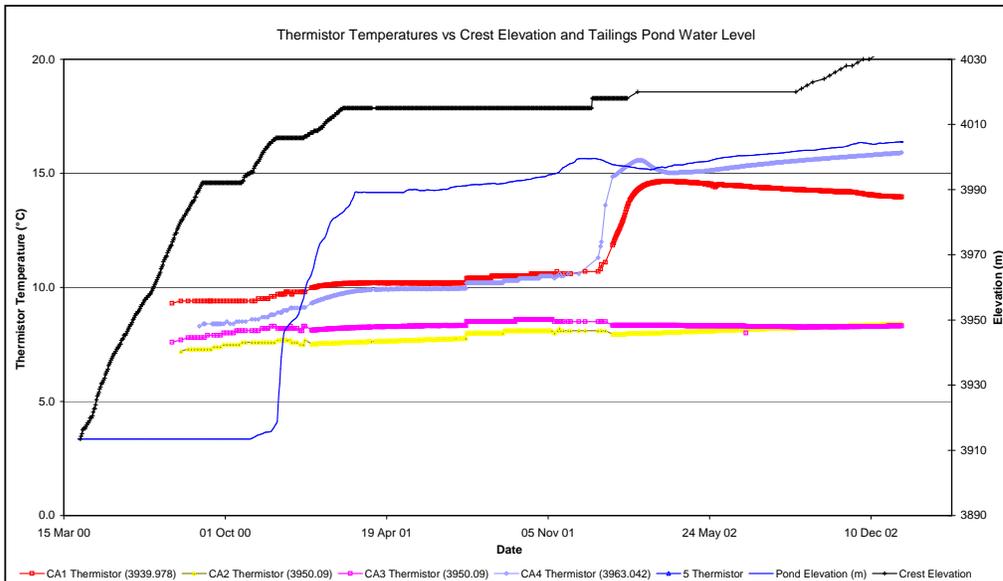
Figure 8
Temperature measurements: CA1, CA4

Each vibrating wire settlement and pressure cell incorporates a thermistor to monitor temperatures within the embankment. Temperatures at settlement cells CA1 and CA4 are plotted below in Figure 8. Temperatures increased rapidly from 10 to 15 degrees in early 2001. This is believed to be the result of cracking of the concrete face and infiltration of the warmer tailings water, as anticipated during design.
